Geological And Hydrogeological Issues

Groundwater flow

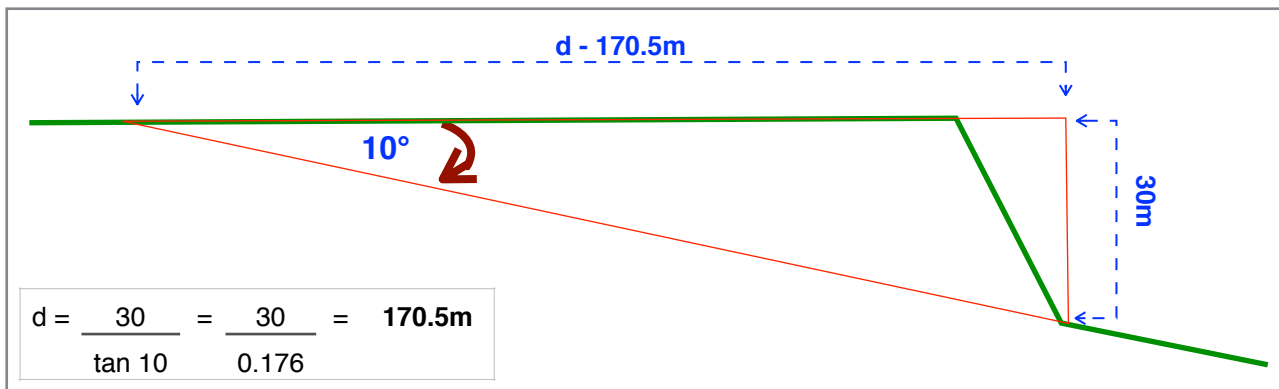
*Given the geological dip of the natural strata recorded at approximately **10- 12degrees** to the east, and the surface water flow from west to east, it is anticipated that the groundwater flow will follow the geological structure of the site and also flow in a west to east direction through the site.*

If the nearest cut is 30m deep then any property within approximately 170m will be lying on or above strata at the base of the excavations. (See diagram below.) Groundwater will be drawn away from the land beneath these properties into the excavations lowering the water table.

The full extent and state of these old pillar and stall excavations have not been investigated by the applicant. It must therefore be considered that they extend beyond the western boundary of the site and will drain into the excavations. This will cause further drawdown of groundwater and lowering of the water table.

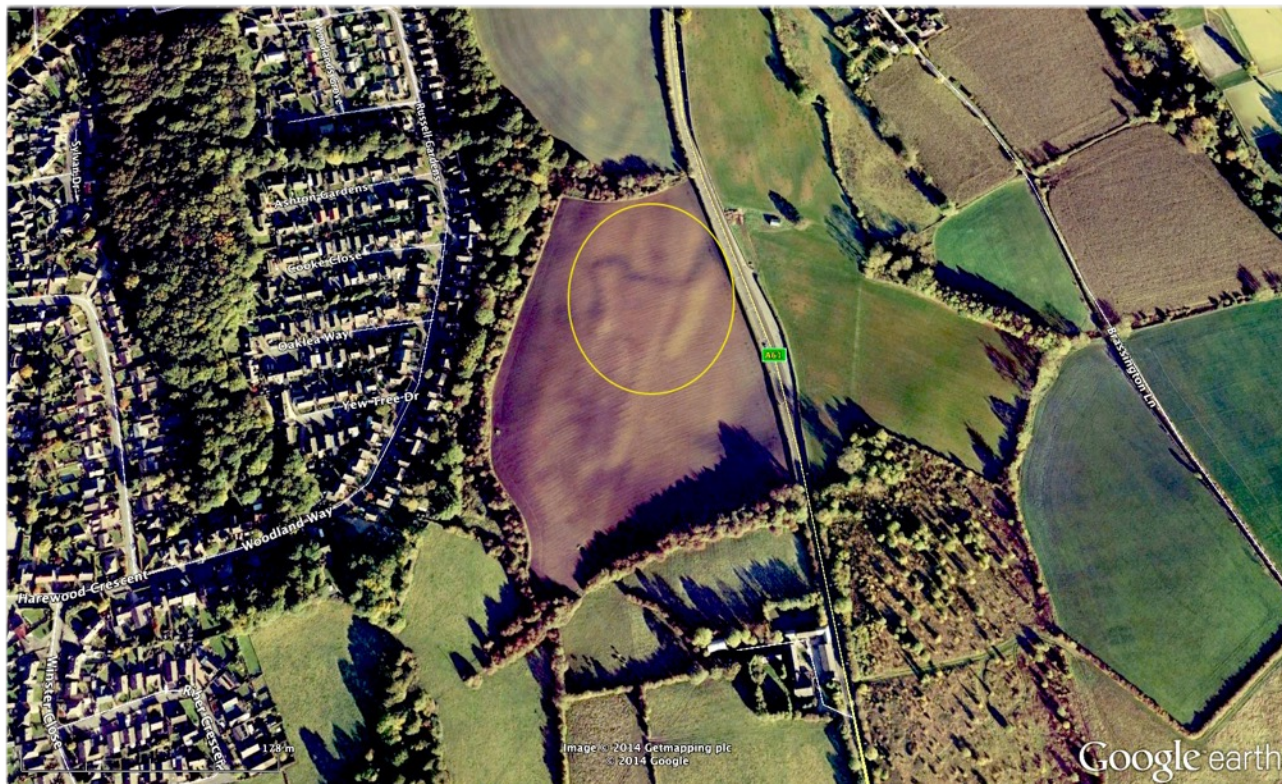
Aerial imagery of the large field to north of Ashover Light Railway clearly shows an anomaly. This is not identified in either the Geological and Hydrogeological Report or the Cultural Heritage Report and has therefore not been investigated.
